# **APPLICATIONS DEVELOPMENT OF CONCRETE POLYMER MATERIALS — A SUMMARY REPORT**

**U. S. Department of the Interior  
Bureau of Reclamation**

1. REPORT NO. REC-ERC-84-21		2. GOVERNMENT ACCESSION NO.		3. RECIPIENT'S CATALOG NO.	
4. TITLE AND SUBTITLE  Applications Development of Concrete Polymer Materials- A Summary Report		5. REPORT DATE February 1985		6. PERFORMING ORGANIZATION CODE D-1510

**APPLICATIONS DEVELOPMENT OF  
CONCRETE POLYMER MATERIALS-  
A SUMMARY REPORT**

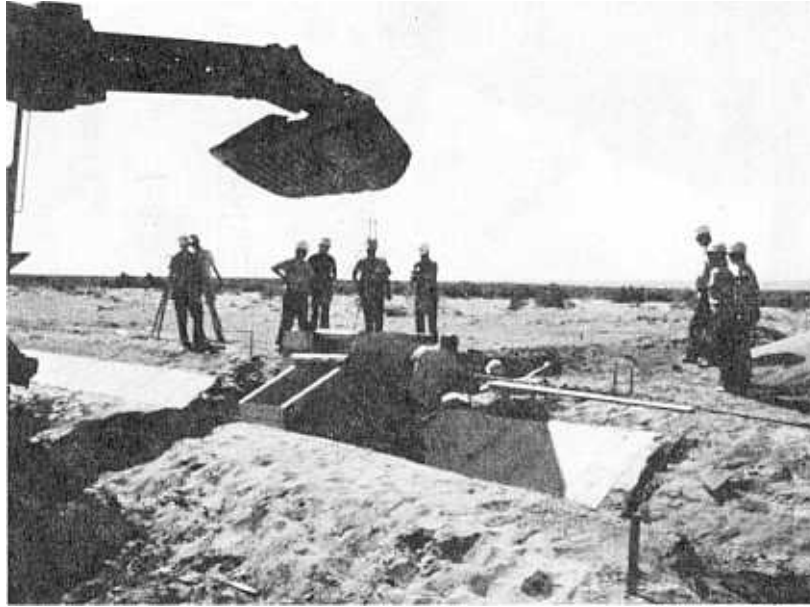
Installation of the CHO structure (fig. 3) was made on July 8, 1975, observed by an engineer from the Division of Research. Because of the light weight of the PIC unit, only a backhoe and slings were needed to set the structure in place.

Figure 3. — Installation of the PIC CHO in the Wahluke Branch Canal Lateral at station 175+35.0 of the WB44E lateral. Photo 801-D-80847

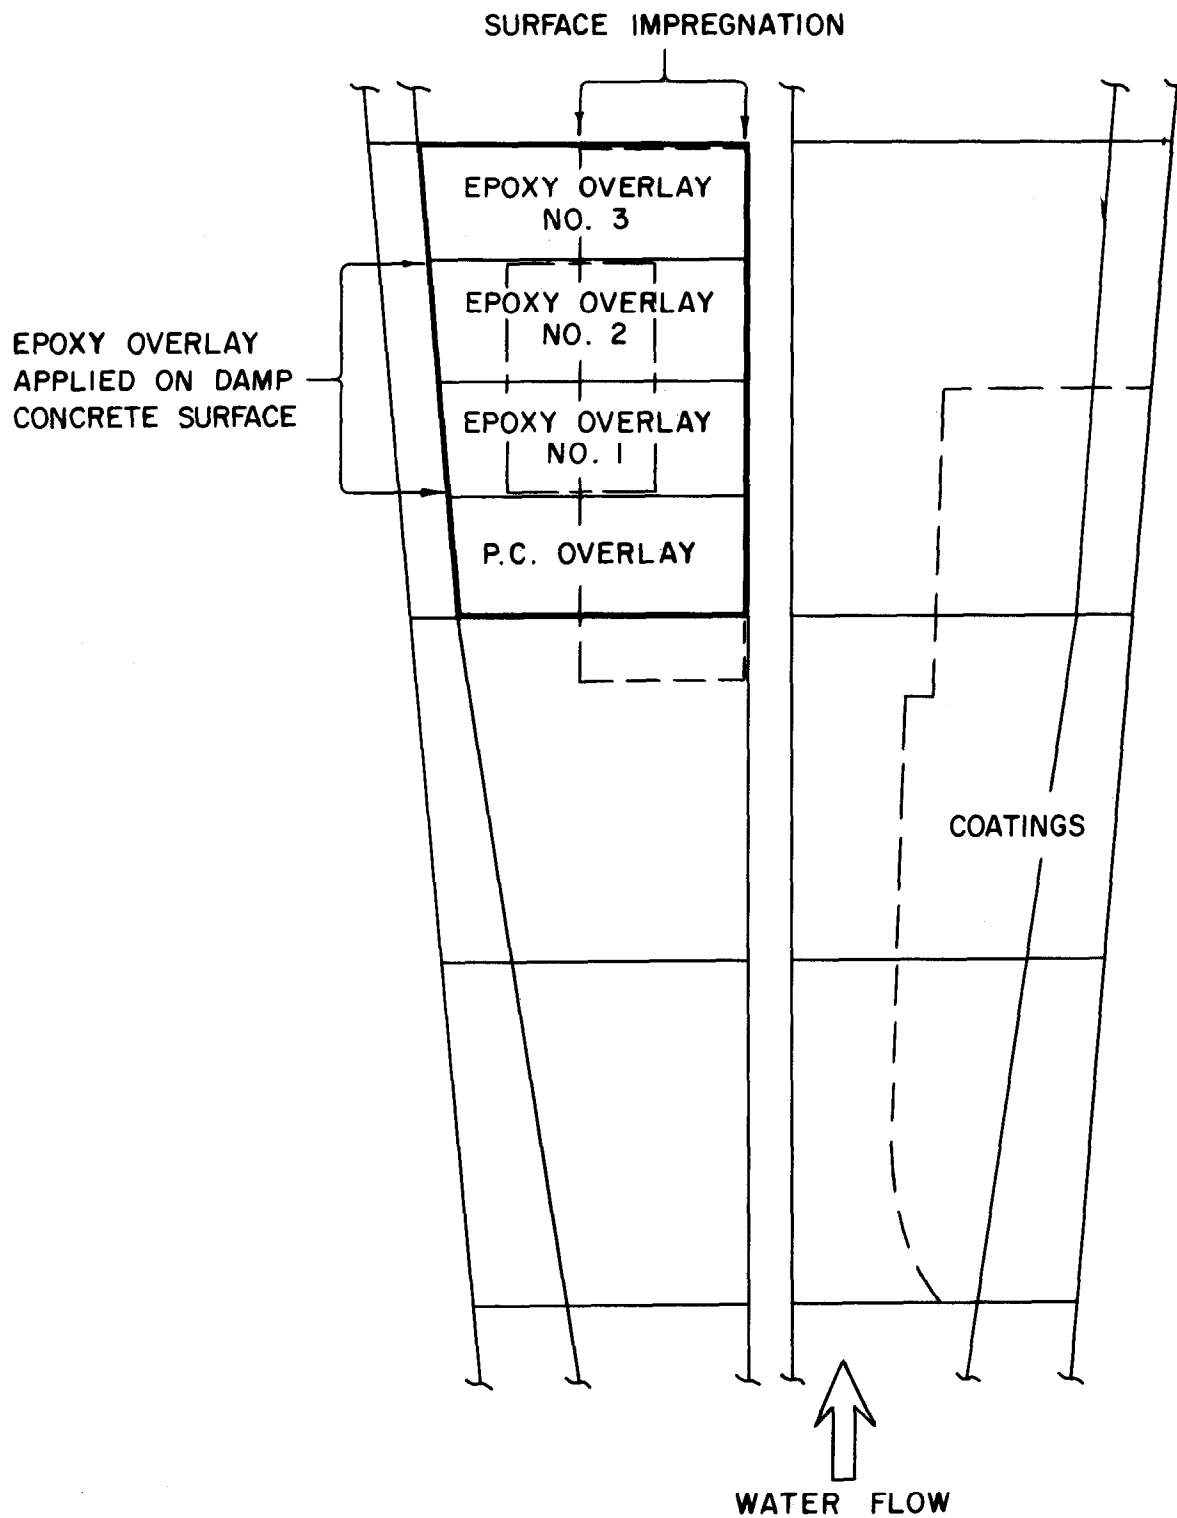
A schematic layout of the experimental repairs on the floor of the spillway is shown on figure 6. Full details of the applications are documented in an interim report entitled "Experimental Repair of Shadow Mountain Dam Spillway" (appendix D). Included in this report are evaluations of performance after 1 month and after 9 months of service.

- a. The exposed surface-impregnated area appeared to be in good condition; further surface deterioration did not occur.
- b. An area coated with only the VE resin showed no further deterioration from the slight erosion found after 1 year.
- c. The VE PC appeared to be in good condition with some minor cracking and slight surface erosion evident.
- d. The Federal specification type epoxy mortar, epoxy overlay No. 3, showed some random cracking, some softening that resulted in surface rippling, and some disbonding.
- e. The two commercial epoxy mortar overlays showed surface deterioration, severe cracking, some softening in No. 2, and drumminess.

Figure 6. – Schematic layout for experimental repairs on the floor of the Shadow Mountain Dam spillway.

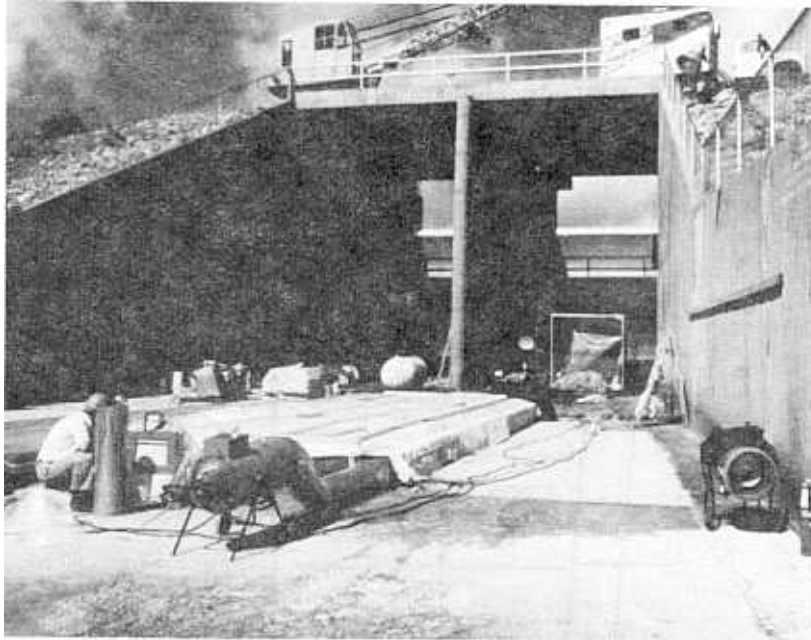
The enclosure used for drying and for polymerization of impregnated monomer in the surface impregnation process during the drying cycle is shown on figure 7. Application of the VE PC (vinyl ester polymer concrete) overlay is shown on figure 8.

Figure 7. – Enclosure used for drying and for polymerization of impregnated monomer in the surface impregnation process during the drying cycle. Photo 801-D-80850

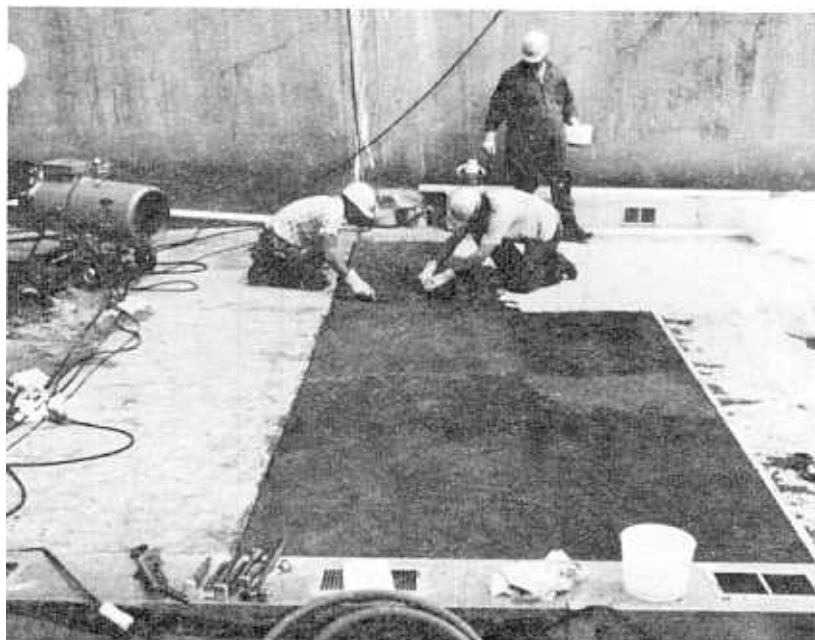
Figure 8. – Application of the vinyl ester PC overlay on the concrete surface. The overlay was applied by hand and trowled on. Photo 801-D-80851

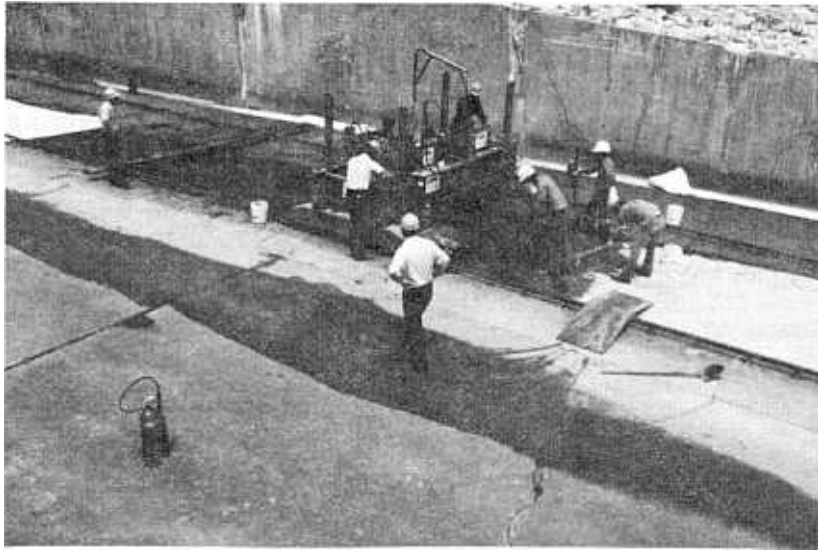
The machine-applied VE PC overlay was placed with the Bidwell concrete paver, which had been designed for placing a dense low-slump concrete (see fig. 9). The objective of this phase of the program was to demonstrate the feasibility of using a concrete paving machine to apply a PC overlay and to observe its performance under field exposure conditions. The concrete paver required no modifications to apply the PC overlay. The overlay was placed on an area of about 8 by 20 m, with a nominal thickness of 25 mm.

Figure 9. – Bidwell Model OF400 concrete paving machine finishing the VE PC overlay during the first field trial. Photo 801-D-80852

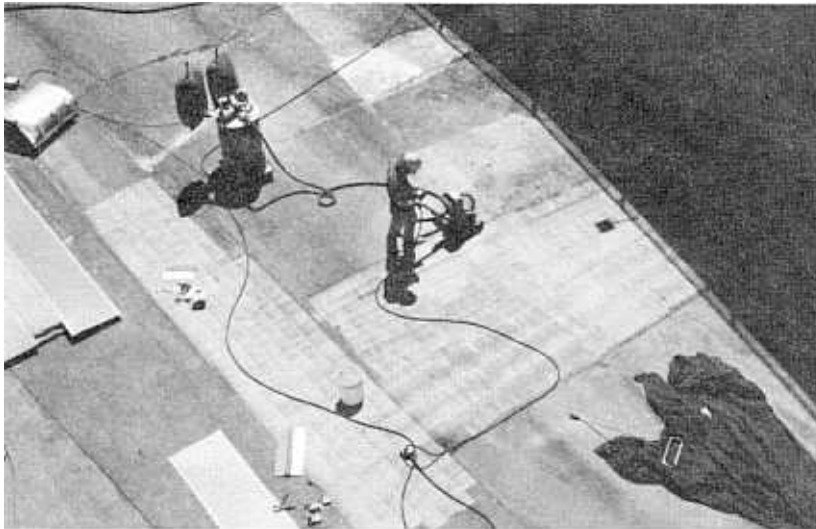
Cleaning was started with a small commercial metal-shot blaster, (see fig. 11), in lieu of sandblasting. However, this process was extremely slow and required numerous passes to satisfactorily clean the surface. In addition, the contractor experienced frequent equipment breakdowns. Eventually, the original blaster was replaced with a new, larger machine that was more effective. The contractor's principal reason for using the new machine was that it almost

Figure 11. — Cleaning the concrete surface with commercial shot blast equipment. The result of the first pass is shown. As many as six passes were needed to get acceptable cleaning. Photo 801-D-80854

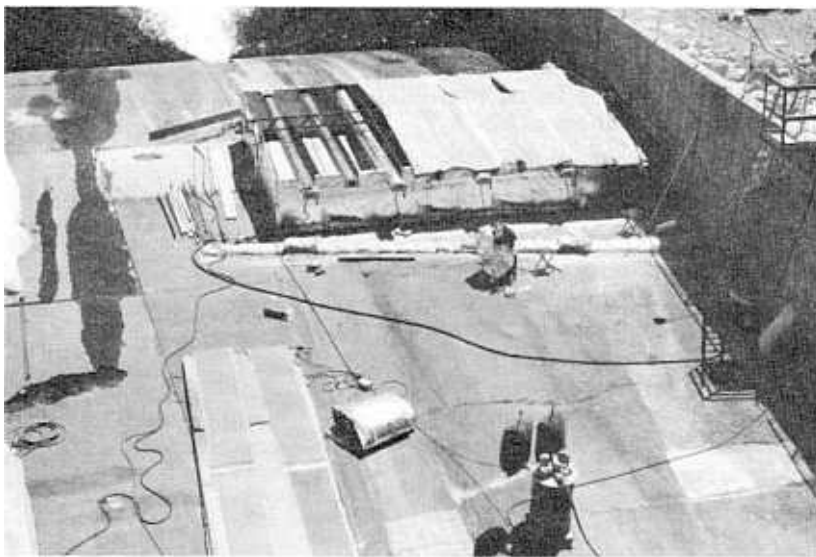
The first enclosure is shown during the cooling cycle on figure 12. In this photograph the roof is partially removed, and the infrared heaters are in place.

The cooling cycle was the most time-consuming part of the process. The specifications required cooling until the surface temperature reached 38 °C. Frequent light showers complicated this matter, and the cooling took as long as 41 hours.

Figure 12. — The first enclosure, during the cooling cycle of the surface impregnation process. Photo 801-D-80855

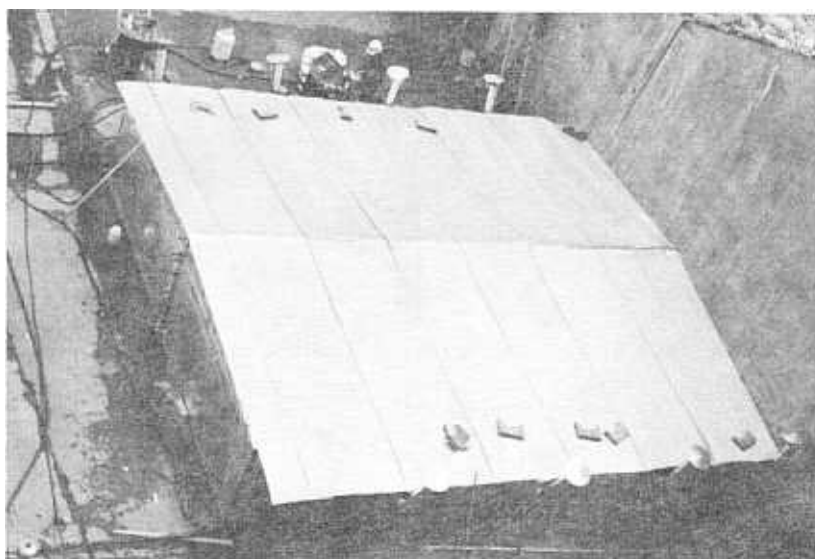
In an effort to maintain dryness, aluminum covers for the insulation roof were fabricated, and during the nonheating cycles these were covered with polyethylene. The aluminum covers on the second enclosure are shown on figure 13. The enclosures were partially disassembled during the cooling cycle to speed cooling.

Figure 13. – The second enclosure, with aluminum covers on the roofing. Photo 801-D-80856

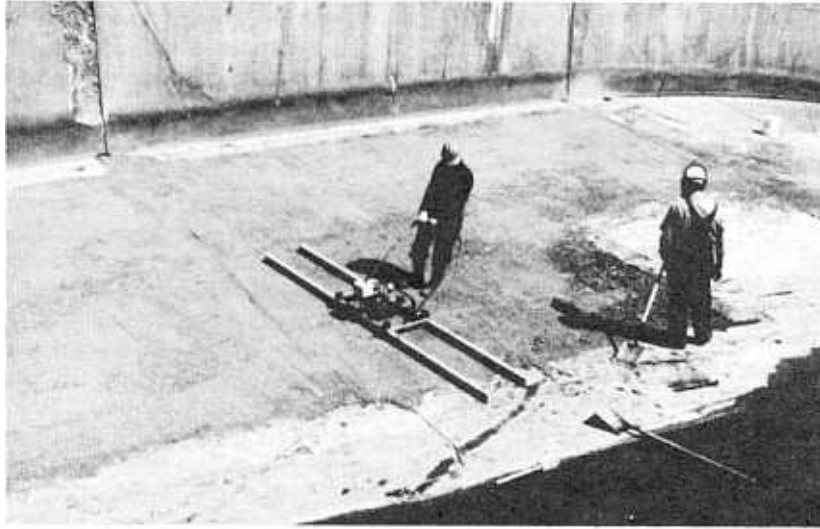
The actual application was made from September 1 to 16, 1981. The removal and cleaning operations produced a number of areas cut about 75-mm into the surface. These were repaired by filling with the VE PC and compacting and rough finishing with a gasoline engine-powered vibrating screed (see fig. 14). Approximately 35 percent of the surface was treated in this way. The patched areas were cured 4 to 5 days and lightly sandblasted just prior to the overlay application. The patches were sound, well bonded to the concrete substrate, and contained only a few small hairline cracks.

Figure 14. – Deep holes in the surface were filled with VE PC and finished with a vibrating screed prior to the overlay application. Photo 801-D-80857

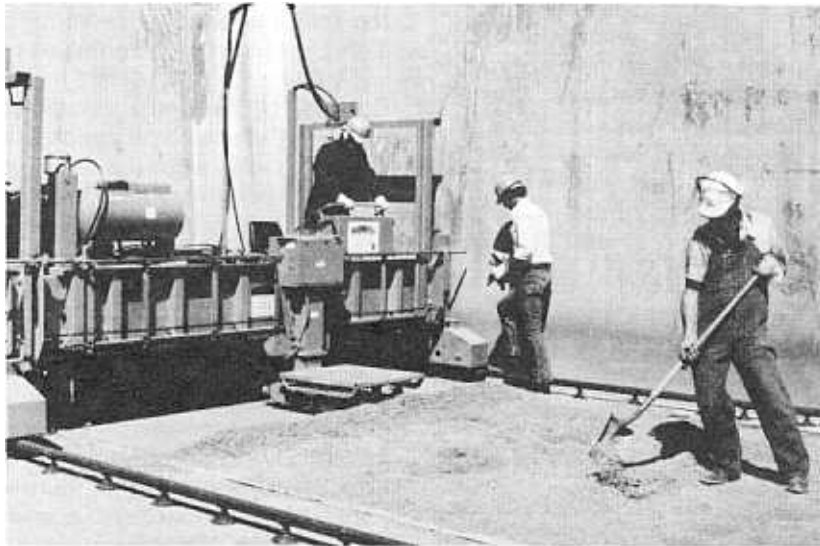
The VE PC overlay was applied in two passes with the Bidwell paver over a period of several days, (see fig. 15). Several problems were encountered including rain on the first day, difficulties in placing and finishing the PC, and premature polymerization of the bond coat and the PC. The overlay was sawcut after the material polymerized to form grooves on about 1-m centers in an attempt to control cracking.

Approximately 2 weeks after completion of the machine application, the overlay was closely inspected. The PC applied during the first pass, before the rain, was in the best condition. This area had been applied over a rubber modified VE primer coat and contained essentially no patched areas. The remainder of the first pass, applied over numerous patched areas, contained frequent cracks and drummy areas. The second pass, with the resin-rich PC mix, contained more cracks and drummy areas than the first. Because these cracks were late in forming, it was thought that the coefficient of thermal expansion was the principal contributing factor. In only one instance did a crack follow a sawcut, otherwise they formed in a random pattern.

Figure 15. – The paving machine applying the VE PC overlay on the first pass. At this point all was going well. Photo 801-D-80858

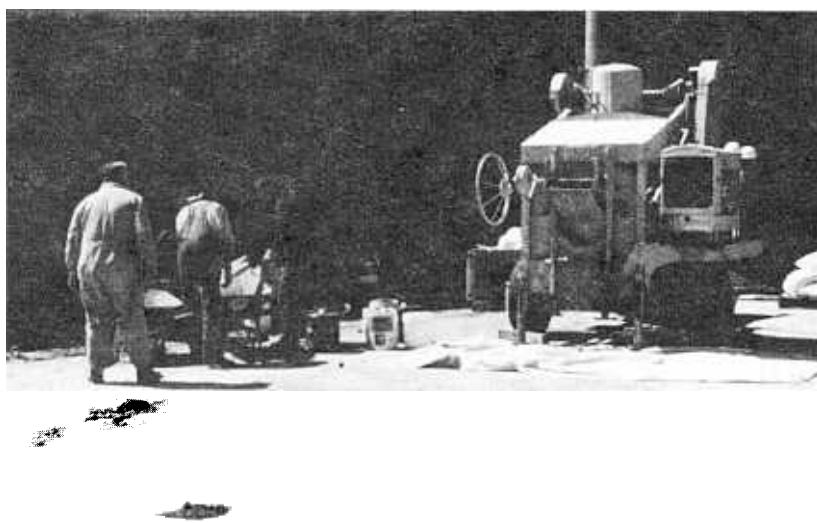
In September 1983, the phase 5 work was accomplished (see fig. 16). As in previous phases of work at Shadow Mountain Dam, project personnel had removed the old overlay and prepared the surface. A three-man crew from the Polymer Concrete and Structural Section assisted the project people in the application.

Figure 16. – The Acrylic PC was mixed in a conventional concrete mixer and placed, screeded, and finished by hand trowelling. Photo 801-D-80859

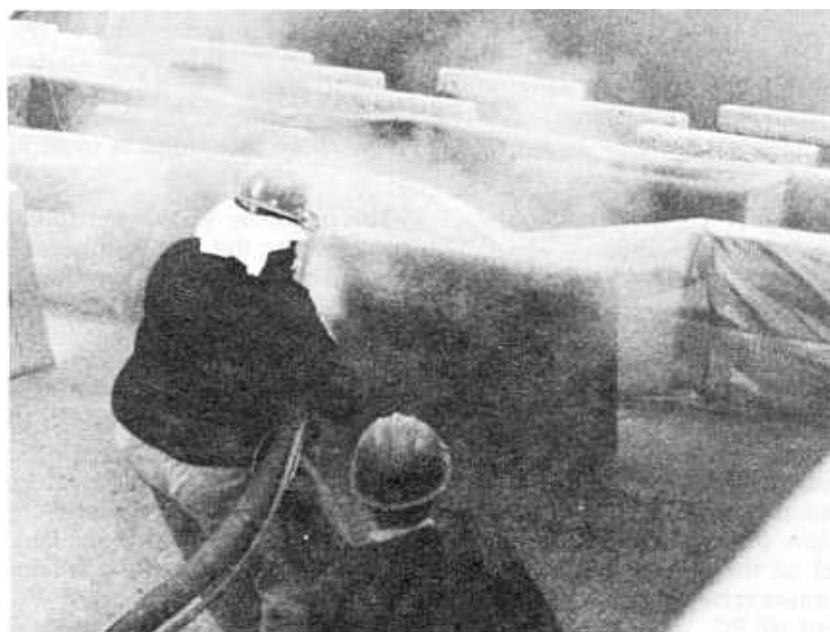
At Azotea Tunnel, the technical feasibility of polymer shotcrete was demonstrated. The application was made by laboratory personnel with assistance by field personnel, from September 13-16, 1976. The nearly vertical upstream surfaces of the concrete baffle blocks were resurfaced with the VE shotcrete (see fig. 17). These surfaces were badly eroded from exposure to sediment-laden waters moving through the system.

Figure 17. – Field application of VE polymer shotcrete to baffle blocks at the outlet of Azotea Tunnel. Photo 801-D-80860

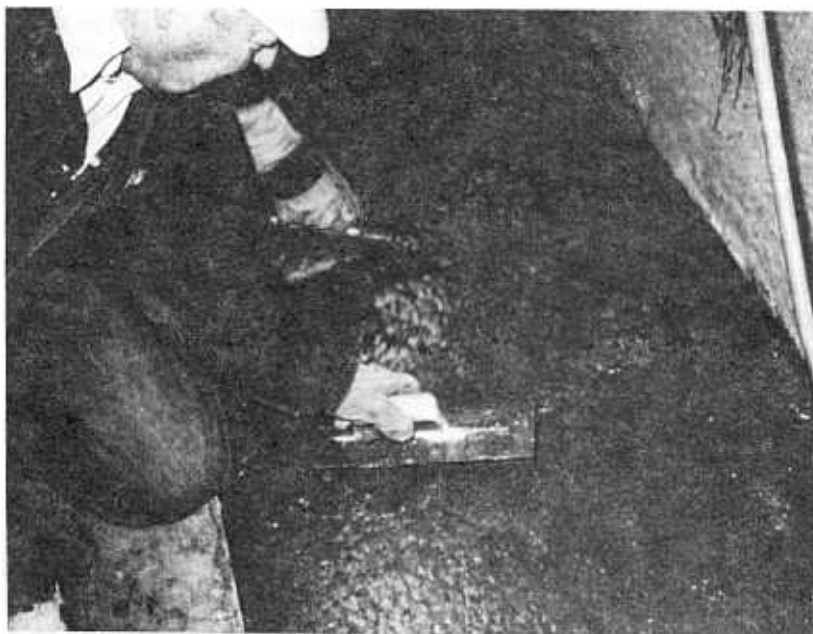
The second application was an installation of a VE PC material around a seal plate on a radial gate in Blanco Tunnel intake (see fig. 18). The purpose was to demonstrate the feasibility of using PC in lieu of epoxy compounds for small, quick repairs. The PC composition is shown in table 6. The repair was made in October 1979. It has not been examined since, because of the high cost of dewatering the tunnel; however, it is presumed to be satisfactory because operating problems with the gate have not recurred.

Figure 18. — Hand placing and finishing the VE PC at Blanco Tunnel. Photo 801-D-80861

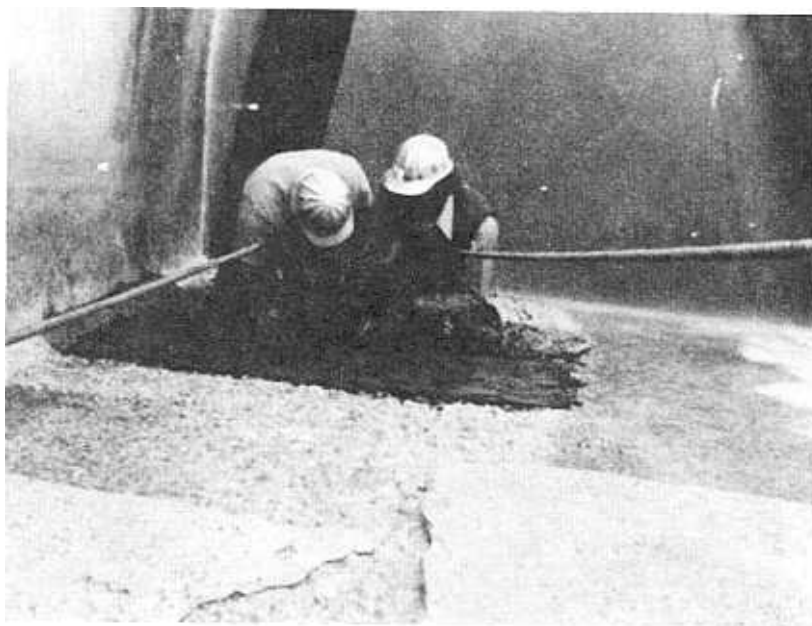
experimental VE PC patches were applied to the lower drop structure in February 1976. Project personnel prepared the surfaces to be repaired and applied the VE PC with technical assistance from research personnel (see fig. 19).

The patches were inspected after each water year by project personnel, with occasional participation by research personnel. Some cracking and only slight wear were apparent after 1 year. After 3 years of operation it was noticed that the aggregate appeared to be wearing at the same rate as the polymer matrix. About this time, the VE shotcrete process had been developed, and tentative plans were made to continue this field testing at Madera Canal with a shotcrete application. The VE PC patches were last inspected in November 1982. Continued wear in the PC was reported, but it was not as severe as in the concrete. Some undercutting was occurring in an upper patch, but little change could be detected in the

Figure 19. – The first field application of VE PC, made on the steep slope of a drop structure on the Madera Canal. Photo 801-D-80862

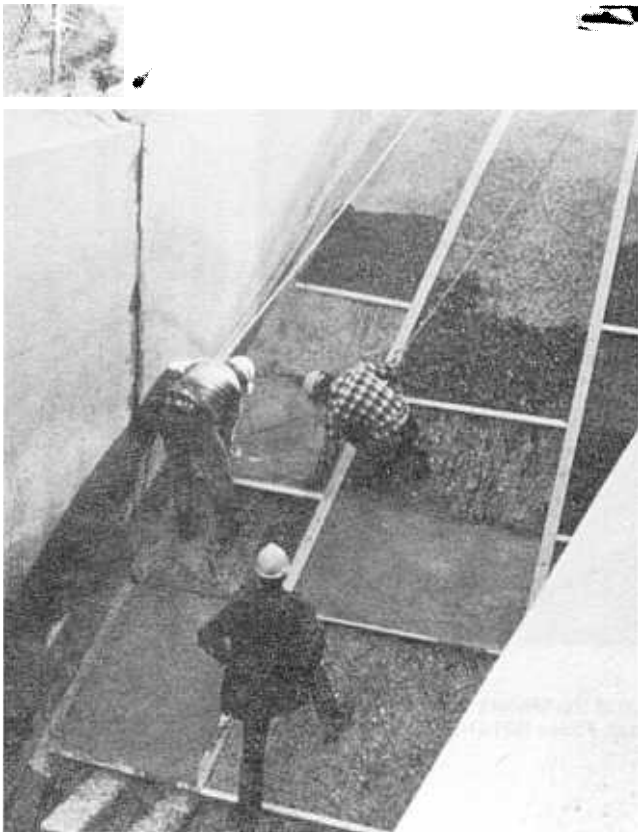
After the floor surfaces were cleaned by sandblasting, longitudinal and lateral wood strips were fastened to the concrete to block out the checkerboard pattern and to provide some support for the fresh PC. The acrylic PC was troweled on alternate sections of the surface by workmen supported by ropes (see fig. 21). The floor of the drop was overlaid with the acrylic PC to a nominal depth of 50 mm. Alternate

Figure 21. — Application of an acrylic PC on a drop structure of the Madera Canal. The checkerboard pattern provided working space and minimized slumping during application. Photo 801-D-80864

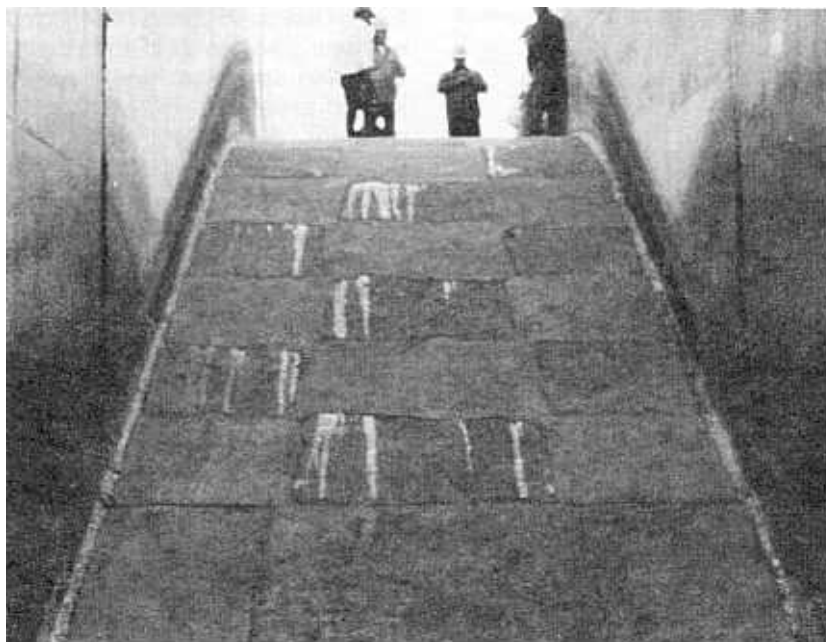
sections were overlaid after the first sections cured, and the wooden strips were removed. The completed checkerboard overlay (see fig. 22) was later smoothed with a thin top coat of acrylic polymer mortar. The baffle blocks at the bottom of the drop were also repaired with the acrylic PC.

Figure 22. – The fully resurfaced sloping floor of the Madera Canal drop structure, before application of a smoothing top coat. Photo 801-D-80865

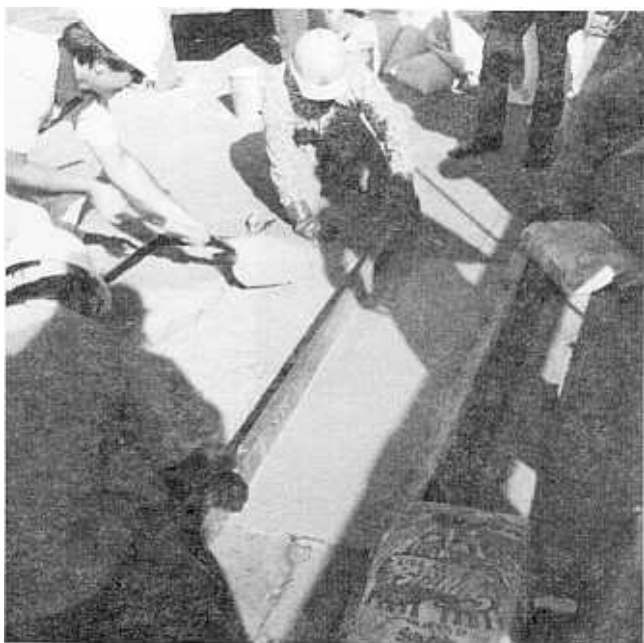
Figure 23. — Screeding one of the trial PC materials placed at Grand Coulee Dam. Photo 801-D-80866

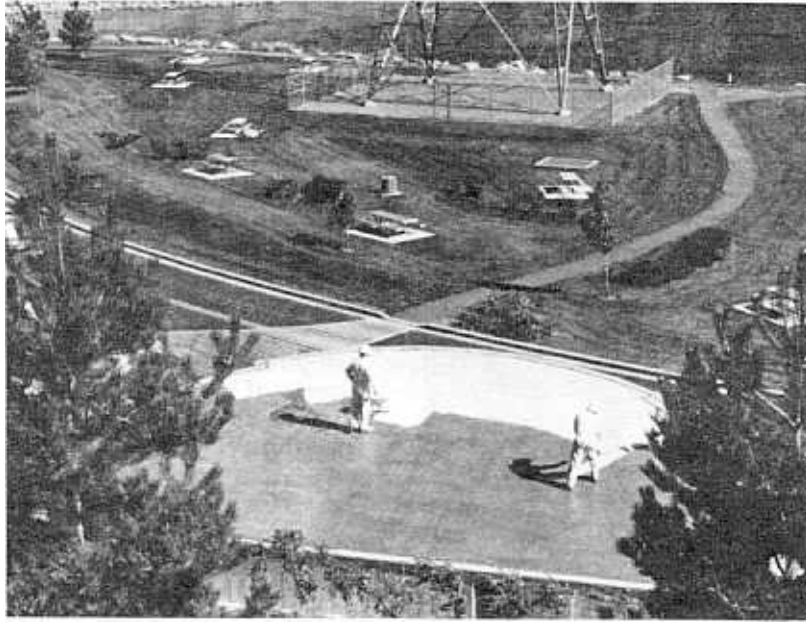
The amounts listed in table 8 are sufficient to overlay approximately 9.75 m<sup>2</sup> with a total thickness of 0.76 mm. The thin polymer overlay handles much like a 100-percent solids coating and can be applied by conventional coatings application techniques (see fig. 24).

Figure 24. – Roller application of the intermediate layer of the thin polymer overlay to the primed roof of a restroom building at Grand Coulee Dam. Photo 801-D-80867

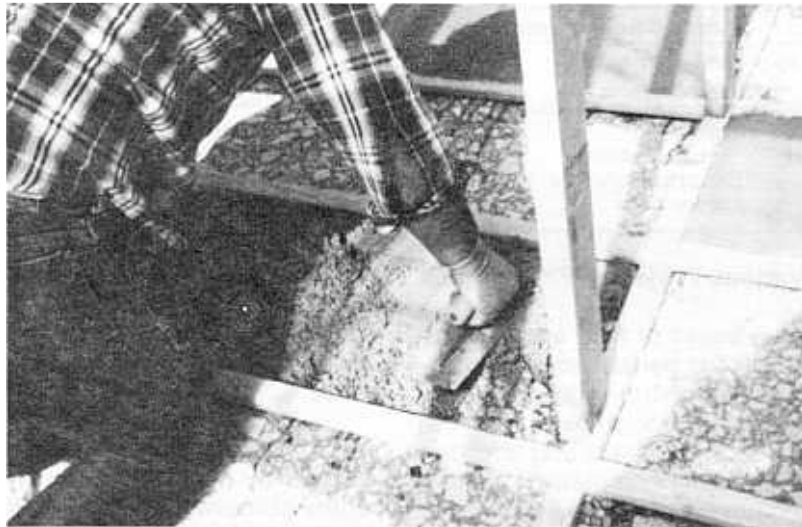
Figure 25. – Placing an acrylic PC in the sluiceway at Milburn Diversion Dam. Photo 801-D-80867

A second inspection was made in June 1982 after one season of sluicing. The PC overlay was found to be sound, but abrading at a faster rate than expected. Maximum wear was measured at about 4.75 mm. Based on these results, several years of service were predicted.

In October 1981, the selected commercial PC was applied by district personnel to the sloping portion of the sluiceway floor on the left chute, on one chute block, and on the face of one baffle block. The right side of the sluiceway floor, which was the area of greatest wear, and the face of the baffle blocks had been repaired first with concrete. These surfaces and the original concrete on the left side of the floor and on the chute block were overlayed with the PC. The repair nearing completion is shown on figure 25. The coatings work was done by Applied Sciences Branch personnel under another program.

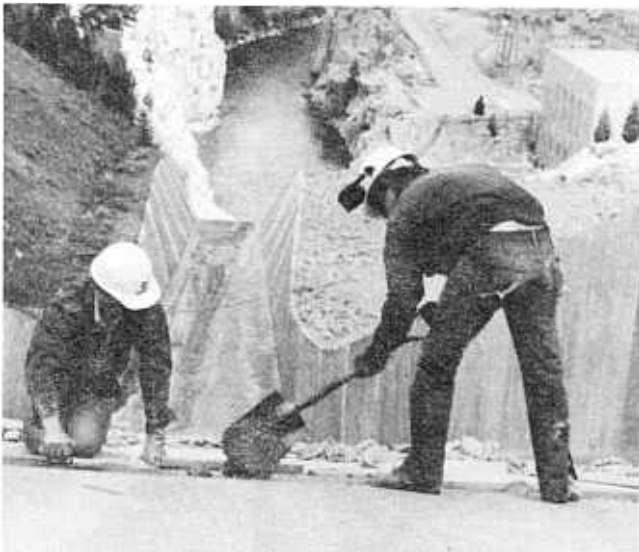
Figure 26. — Application of epoxy concrete on the steep slope of the spillway at Creek Mountain Dam. Photo 801-D-80868

The patches were placed during two periods in June 1983, by project personnel assisted by a three-man crew from the laboratory. The acrylic PC and the epoxy-bonded concrete repairs were easily prepared and placed in the upper crack area. Some difficulties were experienced with the mixing of the epoxy concretes because of their high viscosities and the low ambient temperature in the spillway. Their placement was also difficult because of the steeper slope at the lower crack area (see fig. 26). Temporary forms were required to hold the epoxy concretes in place until they cured. These were plastic-covered plywood sheets held in place by sandbags and buckets. As a result, the surface finishes were somewhat poor.

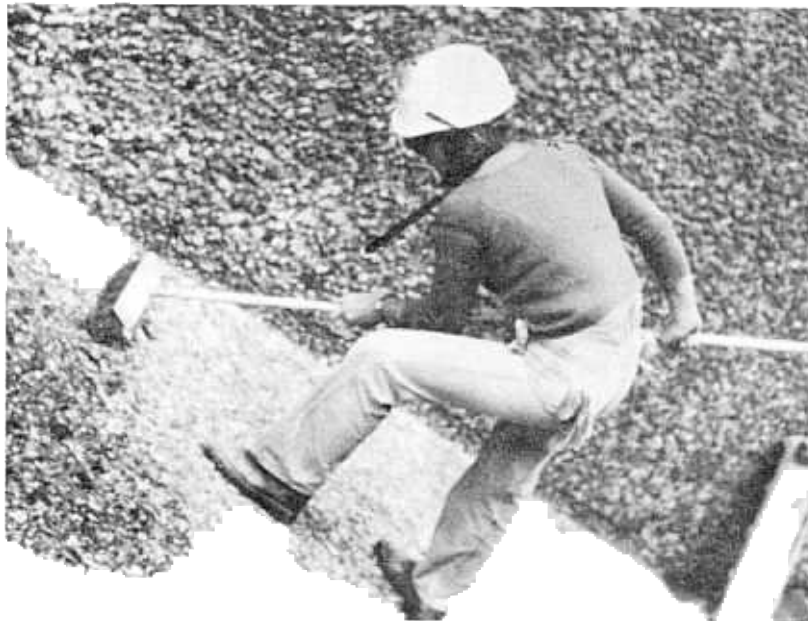
Before the priming could be completed and before any of the intermediate and topping layers could be applied, seasonal rains stopped the work. At this writing, this work has not been rescheduled. Thus, the effectiveness of a thin polymer overlay in corrosive environments is still unknown. However, corrosion-resistance tests are being conducted in the laboratory and at Grand Coulee Dam, but are not yet complete.

Figure 27. — Brush application of the prime layer of thin polymer overlay to the stilling basin at Spring Creek Debris Dam. Photo 801-D-80869

the laboratory. The contractor had considerable difficulty in dewatering and cleaning the concrete, and some delays were experienced. After a portion of the sloped section of the basin was cleaned, application of the prime layer began, (see fig. 27).

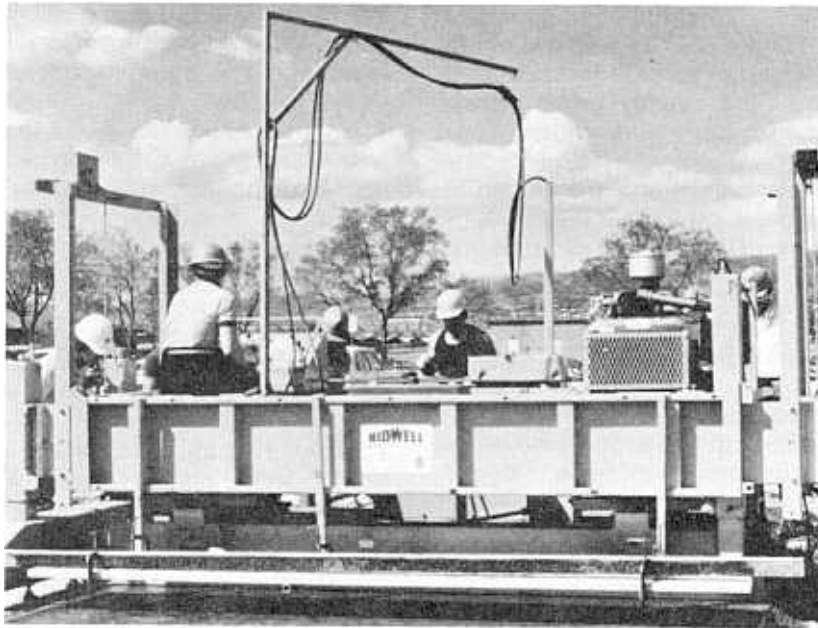
shrinkage cracking, preparatory to phase 4 at Shadow Mountain Dam. The application of one of the trial mixes is shown on figure 28. Grooves were troweled over joints in the sidewalk in an attempt to control the cracking that might occur. However, slight pattern cracking eventually occurred in all of these trials. The last two systems applied to the upper sidewalk, the 8084+BA and the 411C-50 systems, have not pattern cracked.

Figure 28. — A trial PC overlay being machine applied to a sidewalk at the DFC.  
Note the excellent appearance of the finished surface just behind the machine.  
Photo 801-D-80870

Occasional examinations were made, but a detailed evaluation was not made at the conclusion of the DR-381 program. When last examined, all systems appeared to be sound. Reflective cracks at sidewalk joints were evident, but only a few random small cracks could be found elsewhere. The surface roughness present immediately after the applications of those systems with fibers had worn off, and appearances have improved. Since these tests were conducted, the FHWA program has expired; by mutual consent, the planned bridge overlay with VE PC will not be done. Further overlay tests on USBR structures are not planned either. Thus, the improved VE polymer concretes may not be field tested.

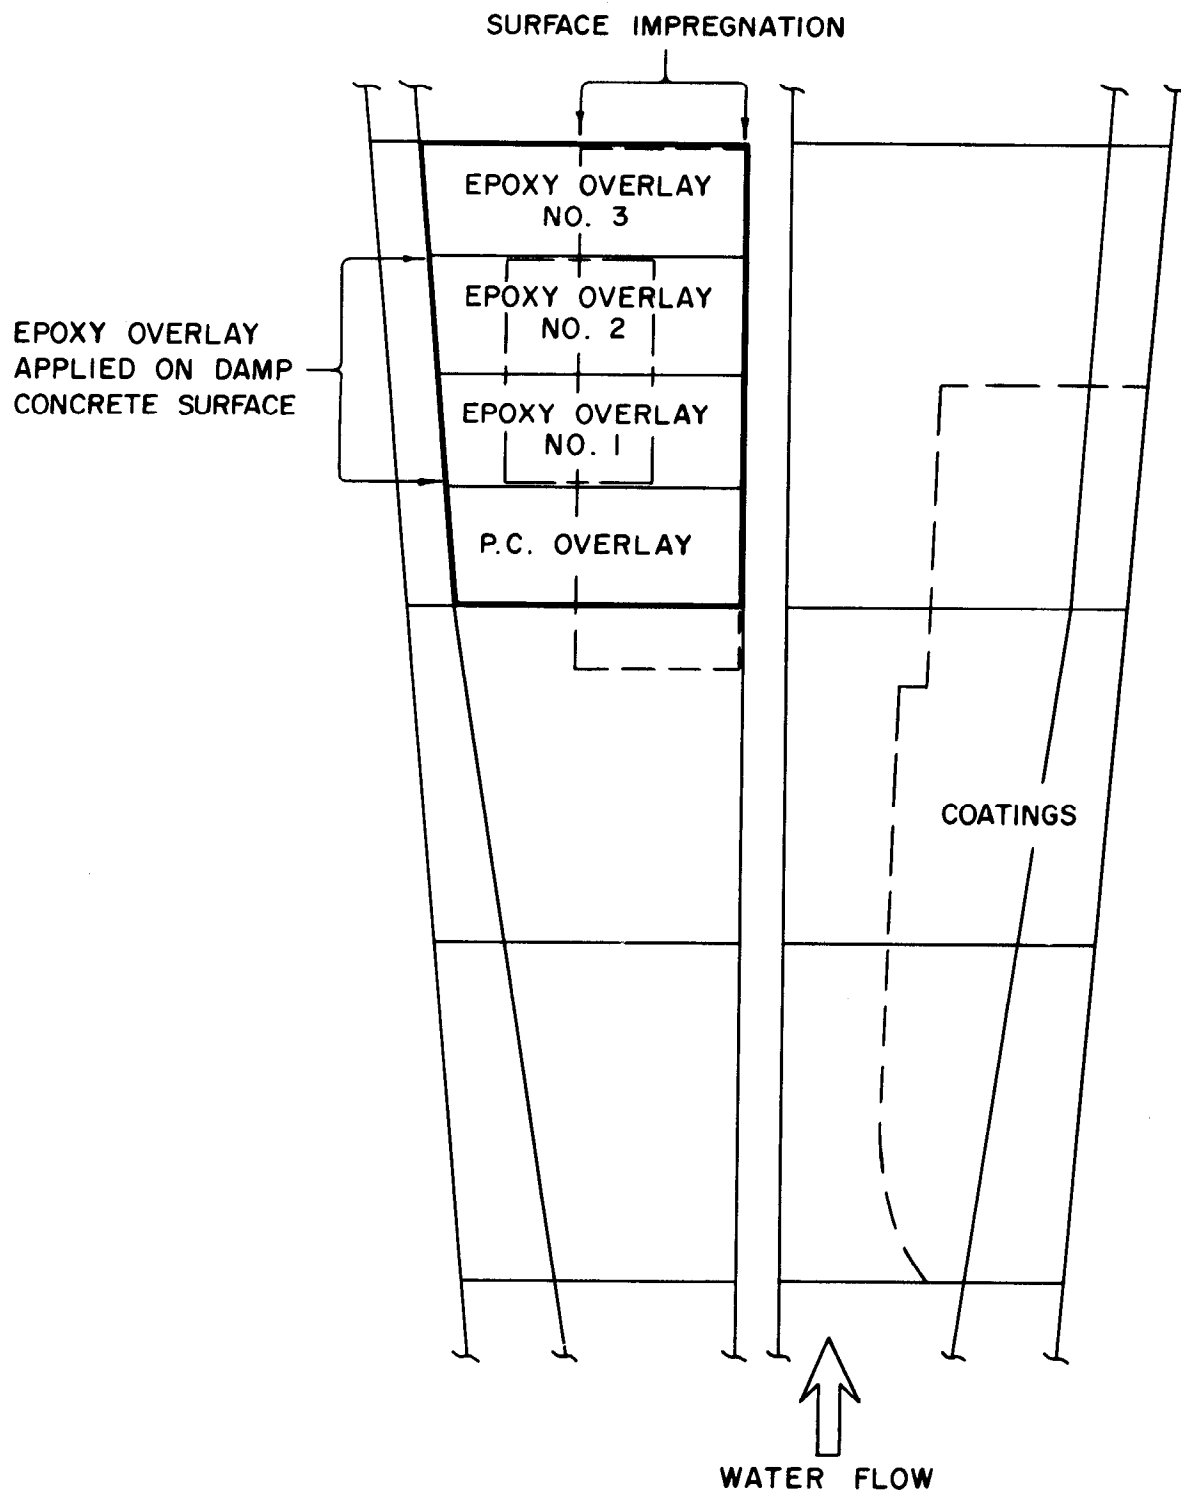
During the inspection of the damaged portions of the spillway, it was determined that freeze-thaw damage was also occurring beneath epoxy mortar patches that had previously been placed. This damage caused disbonding of the patches and failure of the patch as a repair technique.

Figure 1. - Sketch shows schematic layout for the experimental repairs on the floor of the Shadow Mountain Spillway.

A PC overlay was placed on an area 2.1 by 6.1 m (7 by 20 ft) as shown in figure 1. Approximately one-half of the area overlaid, 2.1 by 3.0 m (7 by 10 ft), had received the surface impregnation treatment. Rain had fallen during the night prior to overlay application and the moisture was dried from the surface using two 530-MJ (500,000-Btu) space heaters as shown in figure 11. Water which leaked by the seals of the spillway gates during the overlay application was diverted by dikes made from a fast-setting cement.

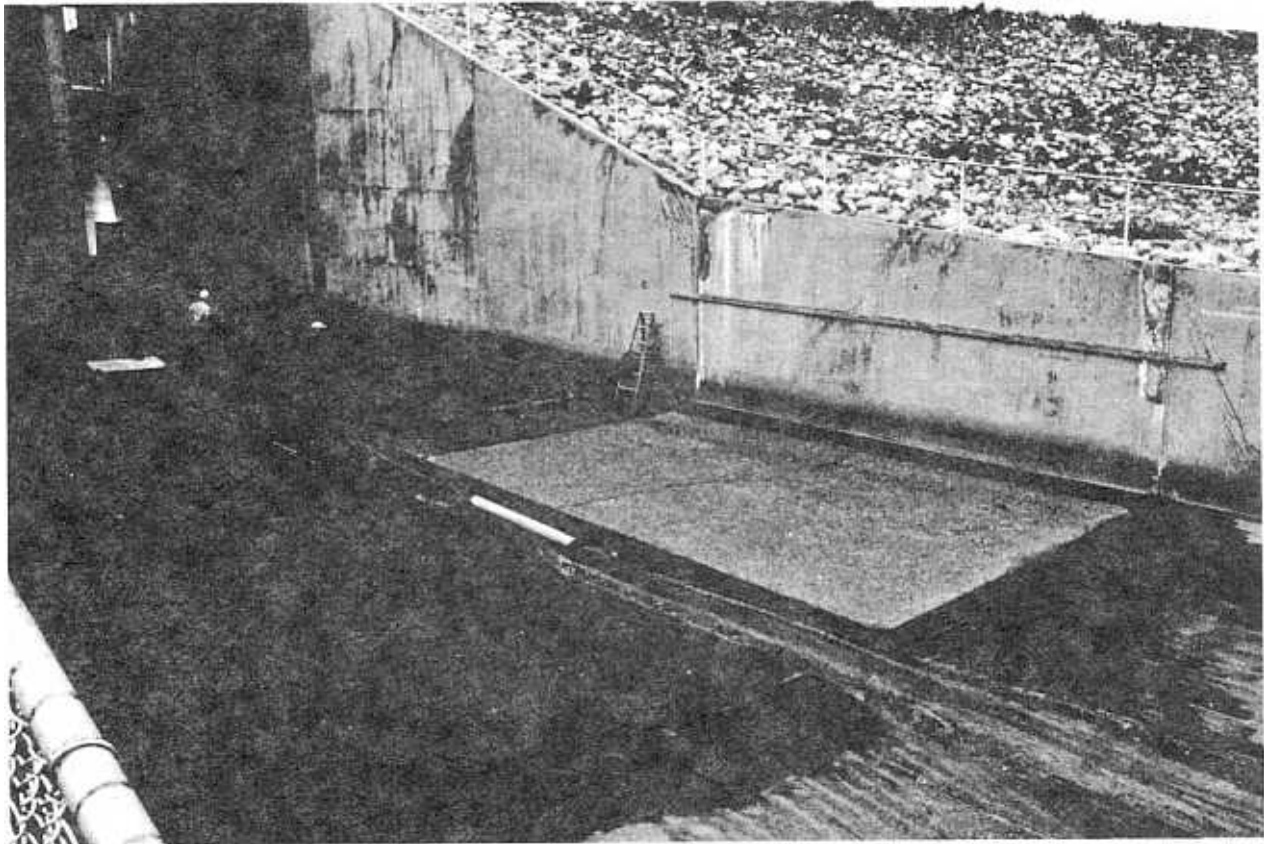
Figure 2. - Spillway area selected for experimental repairs. Area has been sandblasted in preparation for overlays.
